Manhole Inspection Summary

Manhole # S13G1_015MH

Insp Date: **12/22/08 10:43 AM**

Location Address: **Washington Blvd.**

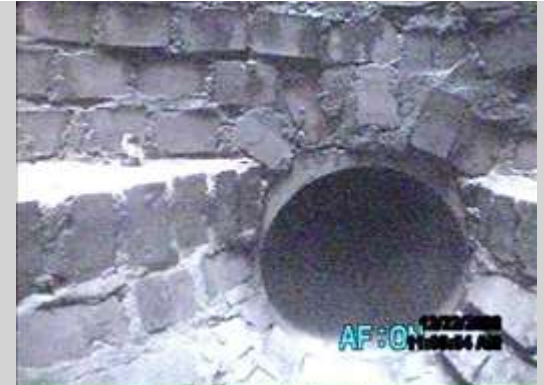
12 O'Clock Outflow

10 in. Circular Gravity Sewer
Pipe Out @ 12 O'Clock

Pipe Height: **10.8** (in.) Rod and Bar (Angled)
Pipe Material: **Clay** ☐ Pipe Lined
Invert Depth: **13.73** (ft.) Flow Characteristics: **None**
Deposits: ☒ None ☐ Mud ☐ Sludge ☐ Debris ☐ Grease
Silt Depth: **0** (in.) Deposits Extent:
Infiltration: **None** Pipe Seal Cond: **Sound**

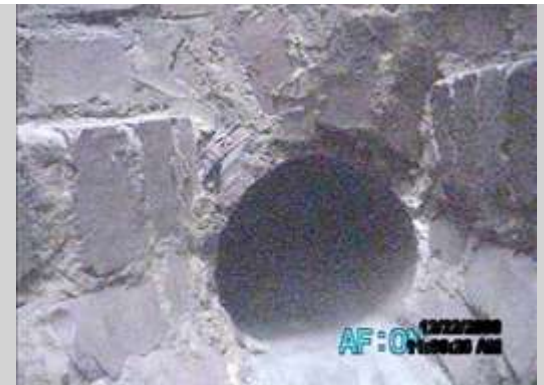
3 O'Clock Inflow

8 in. Circular Gravity Sewer
Pipe In @ 3 O'Clock

Pipe Height: **8.4** (in.) Rod and Bar (Angled)
Pipe Material: **Clay** ☐ Pipe Lined
Invert Depth: **13.63** (ft.) Flow Characteristics: **Slow**
Deposits: ☒ None ☐ Mud ☐ Sludge ☐ Debris ☐ Grease
Silt Depth: **0** (in.) Deposits Extent:
Infiltration: **None** Pipe Seal Cond: **Sound**

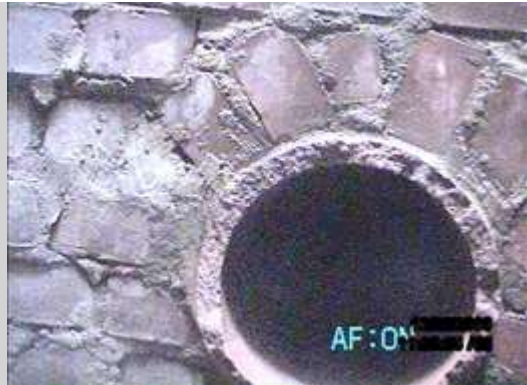
9 O'Clock Inflow

Pipe In @ 9 O'Clock

Pipe Height: **8.4** (in.) Rod and Bar (Angled)

Infiltration: **None** Pipe Seal Cond: **Sound**

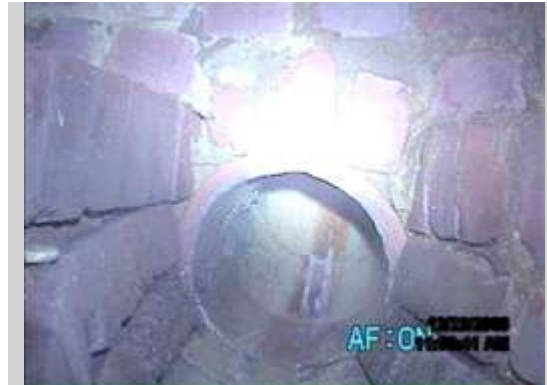
Drop In @ 9 O'Clock

Drop: **Outside** Rod and Bar

Angled: **Yes** Reading: **12.50** (ft.)

Inv Depth: **13.50** (ft.)

Drop Condition: **Open**
